**Flood Control Project Maintenance****2012 Structure Summary Report****Overall Unit and Item Ratings****Reclamation District No. 2096 Wetherbee Lake****Wetherbee Lake Pumping Plant & Navigation Gate**

**Flood Control Project Maintenance****Unit Cover Sheet****2012 Pumping Plant Inspection Results****Reclamation District No. 2096 Wetherbee Lake**

Pumping Plant
Wetherbee Lake Pumping Plant & Navigation Gate

Pumping Plant Rating	<b>M</b>
Date of Inspection	7/18/2012
DWR Inspector	Max Khashchuk
Accompanied By	Randy Barker RD-2096 Wetherbee Lake

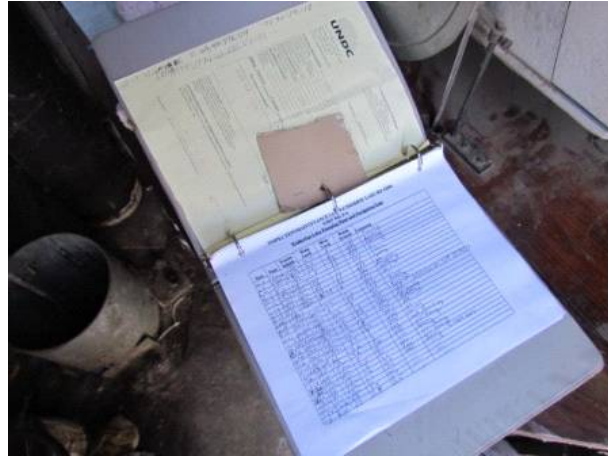
LMR No.	Levee Mile		Category	Item	Location	Rating	Action/Comment	GPS Latitude/Longitude		Issue No.
	Start	End						Start	End	Photo
1	0.00	0.00	Pump Stations	Operating Log		A	Inspector Comments: O&M log presented at time of inspection	37.773593 ° -121.298442 °	37.773593 ° -121.298442 °	1 Y
2	0.00	0.00	Pump Stations	Operation & Maintenance Manual		U	Inspector Comments: O&M manual was not present at time of inspection. LMA is in procees of creating posted operating instructions at pump station.	37.773593 ° -121.298442 °	37.773593 ° -121.298442 °	2
3	0.00	0.00	Pump Stations	Plant Building		A	Inspector Comments: Building protects the controls only.	37.773593 ° -121.298442 °	37.773593 ° -121.298442 °	3 Y
4	0.00	0.00	Pump Stations	Communications		A	Inspector Comments: Trustee has cellular phone.	37.773593 ° -121.298442 °	37.773593 ° -121.298442 °	4
5	0.00	0.00	Pump Stations	Safety		A	Inspector Comments: No hazards noted	37.773593 ° -121.298442 °	37.773593 ° -121.298442 °	5

Levee Mile Report Line	1
Start Levee Mile	0.00
End Levee Mile	0.00
Location	
Category	Pump Stations
Item	Operating Log
07/18/2012 Operating Log	
mkhashch_t_20120719_461.JPG

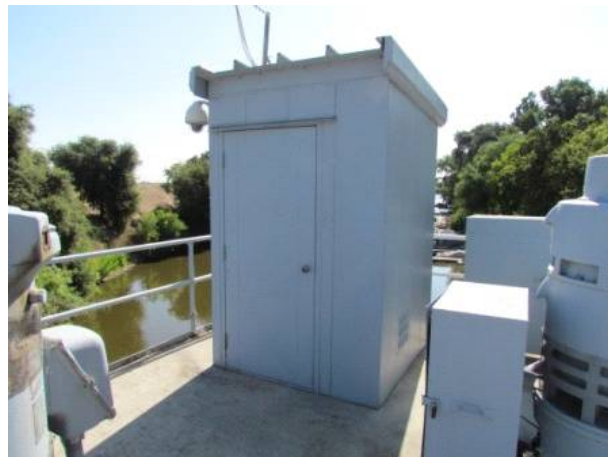
Levee Mile Report Line	3
Start Levee Mile	0.00
End Levee Mile	0.00
Location	
Category	Pump Stations
Item	Plant Building
07/18/2012 Pump operationg building	
mkhashch_t_20120719_462.JPG

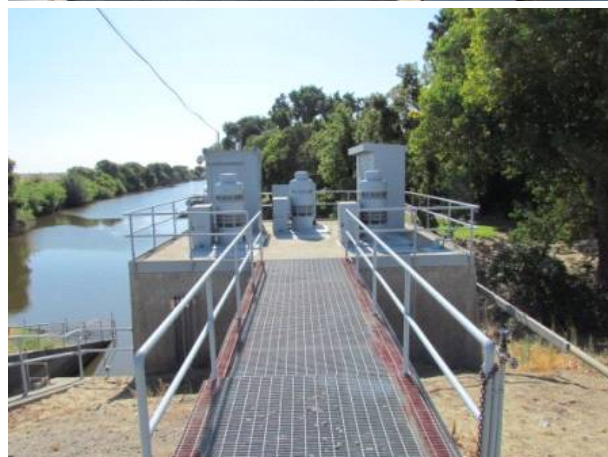
Levee Mile Report Line	3
Start Levee Mile	0.00
End Levee Mile	0.00
Location	
Category	Pump Stations
Item	Plant Building
View of "Building" 07/18/2012	
mkhashch_t_20120719_469.JPG

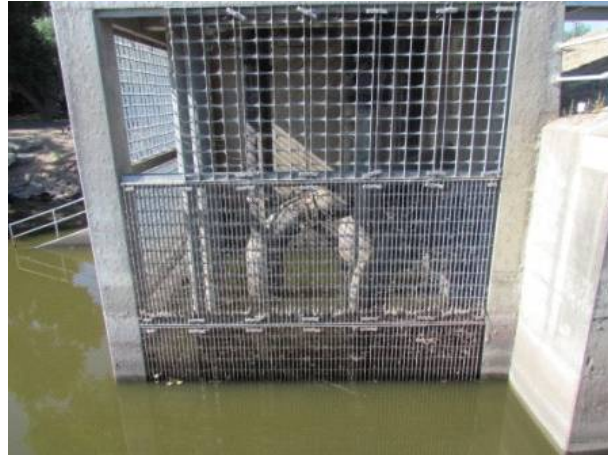
Levee Mile Report Line	12
Start Levee Mile	0.00
End Levee Mile	0.00
Location	
Category	Pump Stations
Item	Trash Racks
07/18/2012 Section of trash rack is missing, missing section would be in upper left of photo.	
mkhashch_t_20120719_463.JPG

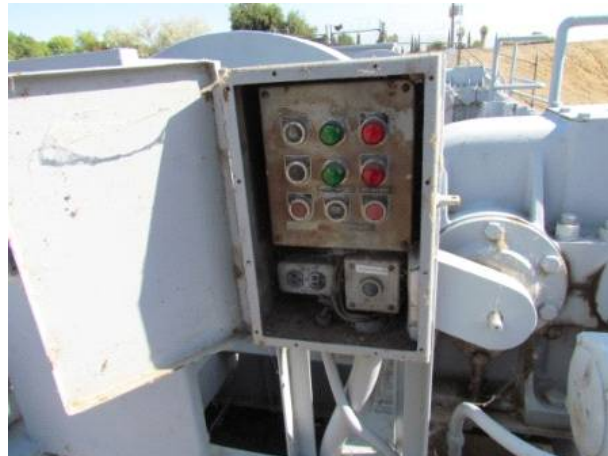
LMR No.	Levee Mile		Category	Item	Location	Rating	Action/Comment	GPS Latitude/Longitude		Issue No.
	Start	End						Start	End	Photo
15	0.00	0.00	Pump Stations	Electric Gate Operators		A	Item inspected visually only. Item was not operated during the inspection. Inspector Comments: Item appears to be in good working condition. Radial arm gate was open at time of inspection.	37.773593 ° -121.298442 °	37.773593 ° -121.298442 °	16 Y
16	0.00	0.00	Pump Stations	Manual Gate Operators		A	Item inspected visually only. Item was not operated during the inspection. Inspector Comments: Manual gate operators appear to be maintained and in good working order.	37.773593 ° -121.298442 °	37.773593 ° -121.298442 °	17 Y
17	0.00	0.00	Pump Stations	Other Metallic Items		A	Inspector Comments: Other exposed metal items are painted or coated to prevent corrosion.	37.773593 ° -121.298442 °	37.773593 ° -121.298442 °	18
18	0.00	0.00	Pump Stations	Flap Gates		A	Inspector Comments: Flap gates appear to be fully operational.	37.773593 ° -121.298442 °	37.773593 ° -121.298442 °	19 Y

Levee Mile Report Line	15
Start Levee Mile	0.00
End Levee Mile	0.00
Location	
Category	Pump Stations
Item	Electric Gate Operators
View of radial arm gate controls. 07/18/2012	
mkhashch_t_20120719_464.JPG

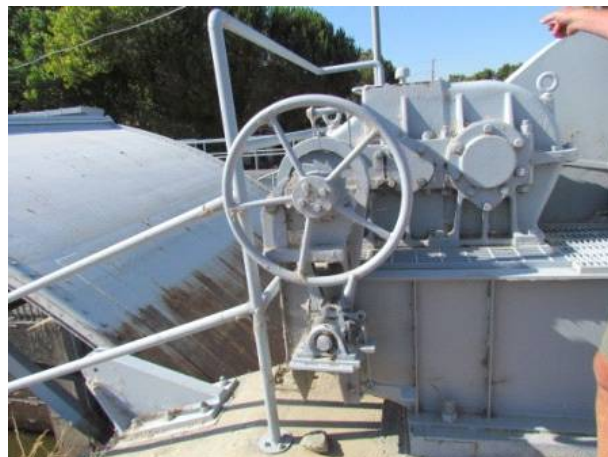
Levee Mile Report Line	16
Start Levee Mile	0.00
End Levee Mile	0.00
Location	
Category	Pump Stations
Item	Manual Gate Operators
View of manual gate operators. 07/18/2012	
mkhashch_t_20120719_465.JPG

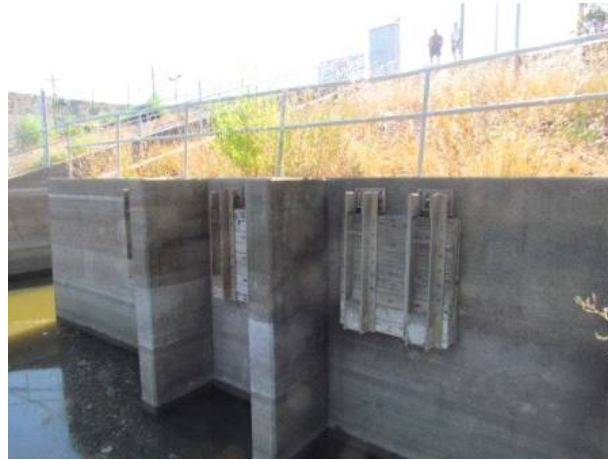
Levee Mile Report Line	18
Start Levee Mile	0.00
End Levee Mile	0.00
Location	
Category	Pump Stations
Item	Flap Gates
View of flapgates. 07/18/2012	
mkhashch_t_20120719_466.JPG

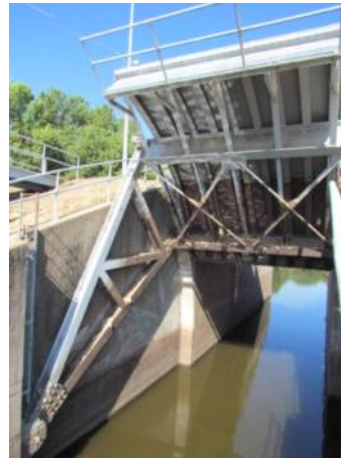
19	0.00	0.00	Pump Stations	Closure Structures		A	Inspector Comments: Radial arm gate acts as closure structure, gate was open at time of inspection.	37.773593 ° -121.298442 °	37.773593 ° -121.298442 °	20 Y
20	0.00	0.00	Pump Stations	Security Fencing		A	Inspector Comments: Security fencing is in place. Closed circuit cameras are also in place.	37.773593 ° -121.298442 °	37.773593 ° -121.298442 °	21 Y
21	0.00	0.00	Pump Stations	Intake and Discharge Pipes		A	Item inspected visually only. Item was not operated during the inspection. Inspector Comments: Pipes appear to be free of defects.	37.773593 ° -121.298442 °	37.773593 ° -121.298442 °	22

Levee Mile Report Line	19
Start Levee Mile	0.00
End Levee Mile	0.00
Location	
Category	Pump Stations
Item	Closure Structures
Radial arm gate, shown in open position. 07/18/2012	
mkhashch_t_20120719_467.JPG

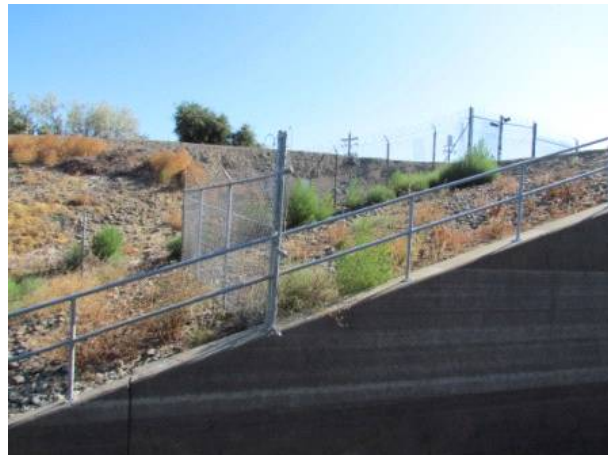
Levee Mile Report Line	20
Start Levee Mile	0.00
End Levee Mile	0.00
Location	
Category	Pump Stations
Item	Security Fencing
View of typical security fencing.	
mkhashch_t_20120719_468.JPG
